West Inspect LLC

Inspection reference: 1092

# Confidential Inspection Report

54321 45th St N  
Seattle WA

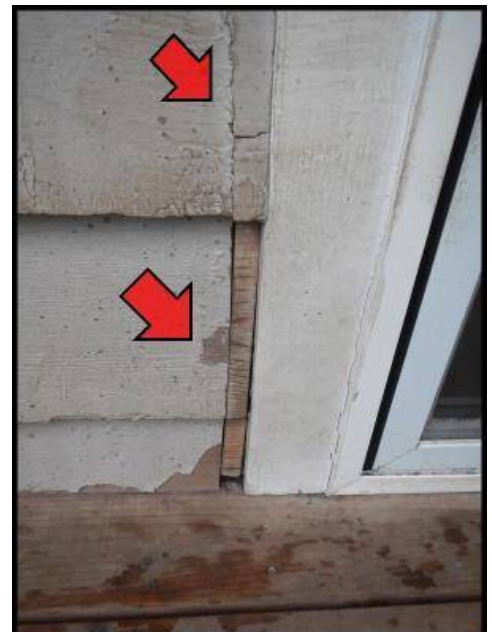
#### 3.6 Condition Damaged

A small section of the wood siding was damaged.

This was observed on the Rear Side.

*SUGGESTION:* All damaged materials should be repaired or replaced by a contractor in accordance with industry standards.

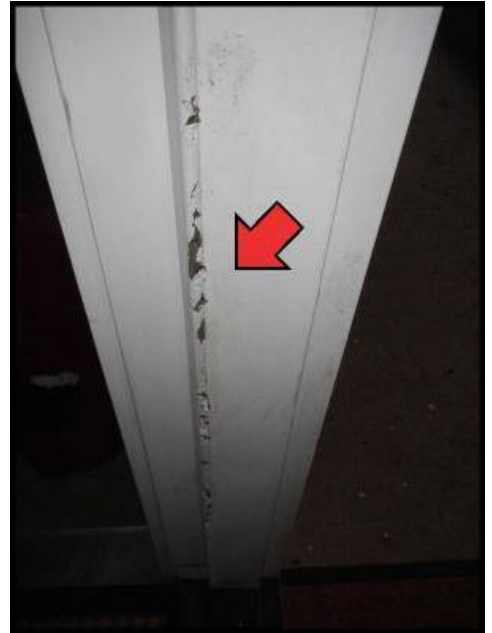
### 3.7 Door Seals

The weather-stripping around the doors was damaged. This will affect the air draft and energy efficiency.

This was observed on the Front Side of the dwelling.

*SUGGESTION:* We recommend repair to the seal to ensure air tight and eliminate drafts.

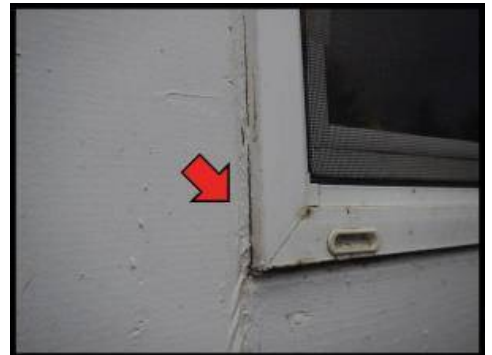
### 3.8 Condition

This was observed at Several Sides.

*SUGGESTION:* We recommend caulking to help prevent moisture intrusion.

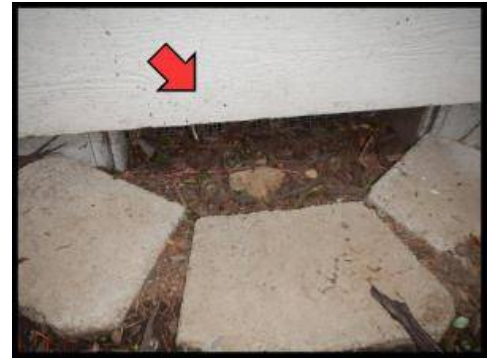
### 3.10 Conditions

The foundation vents were at or below grade level. This condition allows moisture infiltration into the Crawl Space.  
*SUGGESTION:* Consideration should be given to the installation of some type of water diversion to divert water away from the entry points.  
This condition was observed on Several Sides of the dwelling.

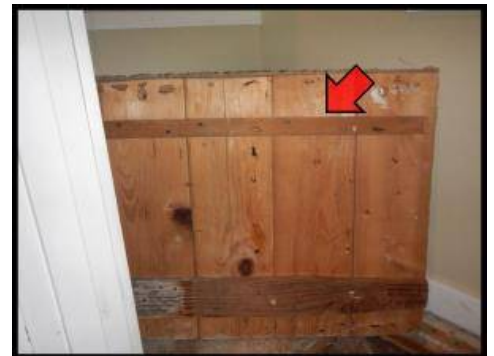
#### 4.5

The Crawl Space hatch door was missing insulation.  
**SUGGESTION:** Installing insulation on the hatch door is recommended.

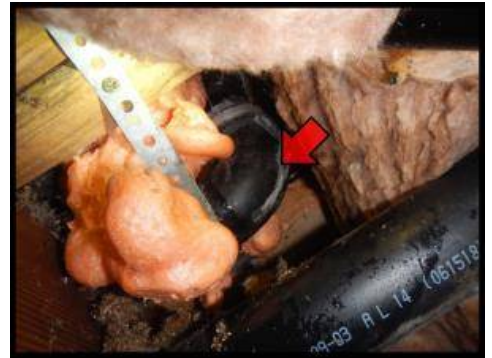
#### 4.7 Deterioration/Leaks

The bathtub drain was leaking.  
*SUGGESTION:* We recommend the drain be repaired or replaced.  
This was observed under the Hallway Bathroom.

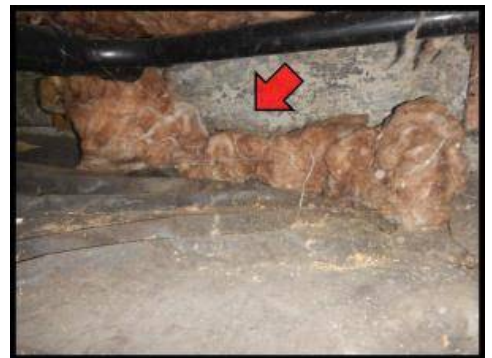
4.8

There was one area where the insulation has come loose and fallen down, leaving areas without insulation.  
*SUGGESTION:* All displaced or improperly installed insulation should be secured back in place, and new insulation installed where necessary.

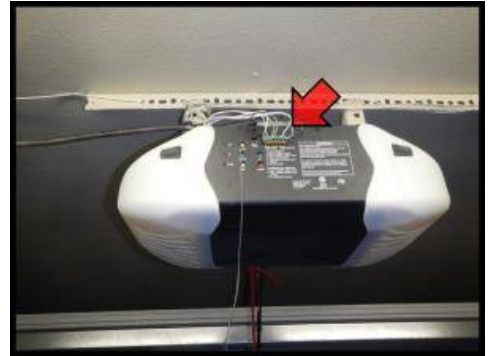
The downward travel of the Garage door opener was stopped when it met resistance, however excessive down resistance force was observed. This means that damage or injury may still occur before the door reverses.

*SUGGESTION:* Repair or adjustment should be done.

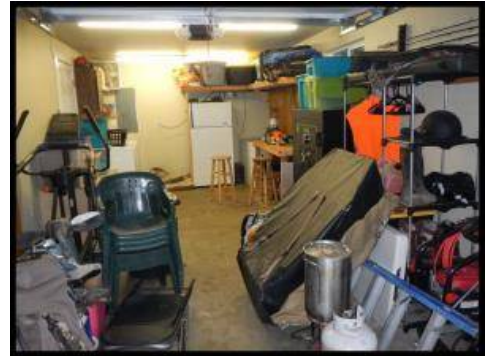
This area was cluttered or blocked with several of the homeowners personal belongings during our inspection. This condition limited our inspection in some areas.

*SUGGESTION:* We suggest a pre-closing walk through once the area is vacant.

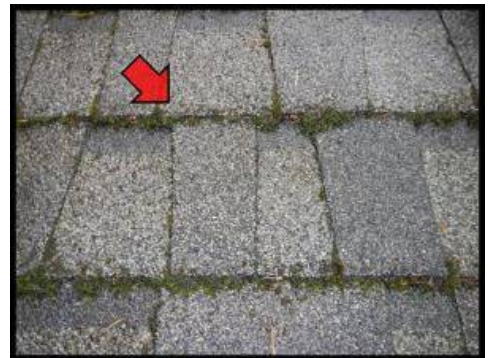
6.14

Moss, lichen and/or debris from trees was observed on the roof surface. This will restrict drainage off the roof and into the gutters/downspouts.

*SUGGESTION:* Debris and moss on the roof should be cleaned and/or removed to reduce the potential for damage to the roofing materials.

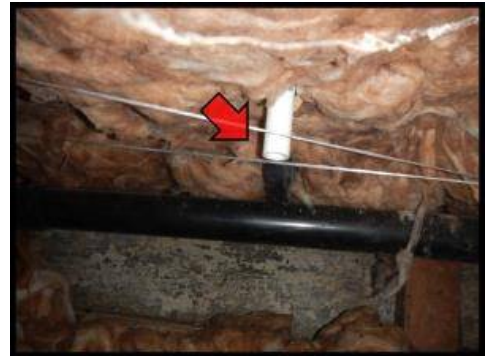
The discharge piping drained into the crawl space. This is not approved for this type of application.

*SUGGESTION:* We recommend removal and approved materials and fittings be installed in accordance with industry standards.

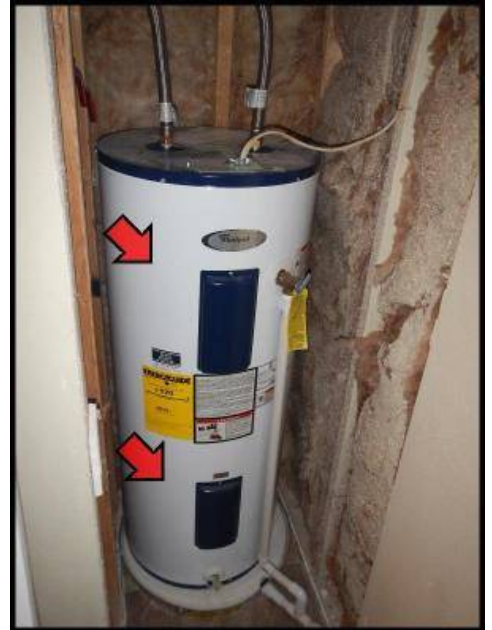
#### 10.8

The water heater lacked seismic restraint.  
*SUGGESTION:* As an upgrade, the water heater should be secured to help limit damage and provide a source of usable domestic water in the event of a major earthquake.

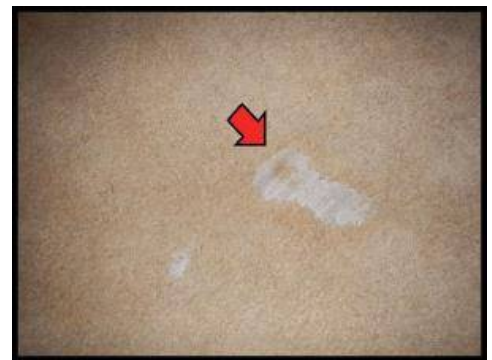
#### 11.9 Floor Conditions

The carpets are damaged in some areas.

This was observed the Front Left Bedroom and the Living Room.

**SUGGESTION:** We recommend cleaning and/or repair/replacement.

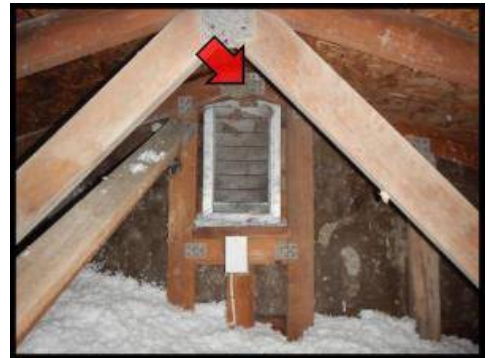
This was observed on both sides of the attic.

**SUGGESTION:** We advise the screen be replaced per industry standards for proper venting into the Attic.

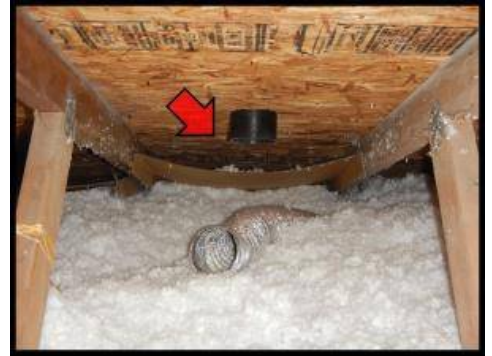
#### 12.9

The Bathroom exhaust vents terminated in the Attic. This can lead to excessive moisture in the Attic.

This was observed for the Hallway Bathroom.

*SUGGESTION:* We recommend a general contractor repair the vent in accordance with industry standards and that it routed to the Exterior at a back-draft damper.

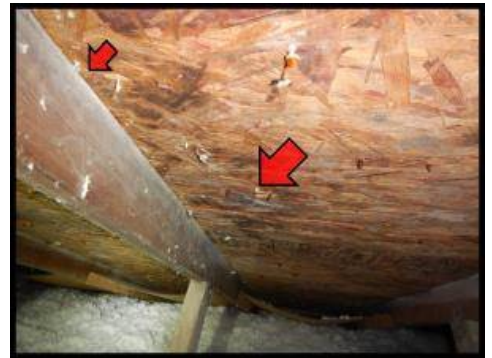
12.10

A mold like substance was observed on the structure in the Attic.

*SUGGESTION:* We recommend to improve ventilation, seal all voids in the ceiling surfaces and wash off the areas with a water/chlorine solution. Monitoring and/or testing will then be required and/or consulting a mold specialist could be done.

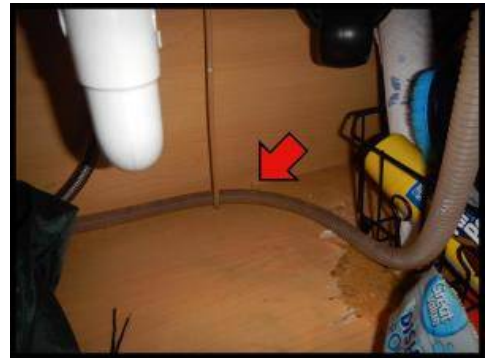
#### 14.3 Condition

The dishwasher discharged through a hose which had been routed up to the underside of the sink to the countertop, before dropping down to the discharge connection. The pipe is NOT secured or not properly routed at the underside of the counter. This configuration is not in accordance with industry standards.

*SUGGESTION:* Repair of this condition is recommended.

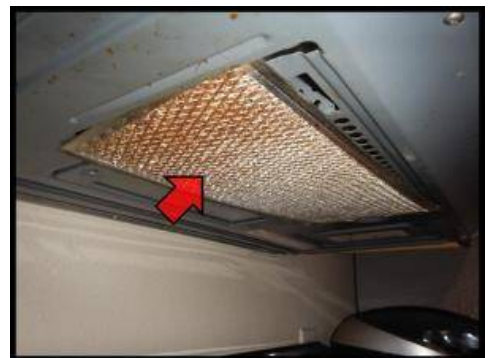
The filter for the Kitchen ventilation operated, however, this type will become heavily grease-laden in the future. This can become a fire hazard.

*SUGGESTION:* Thoroughly cleaning is recommended as needed in the future.
